40-500

1/2" - 2"

American Backflow
Products Company

Modification Overview

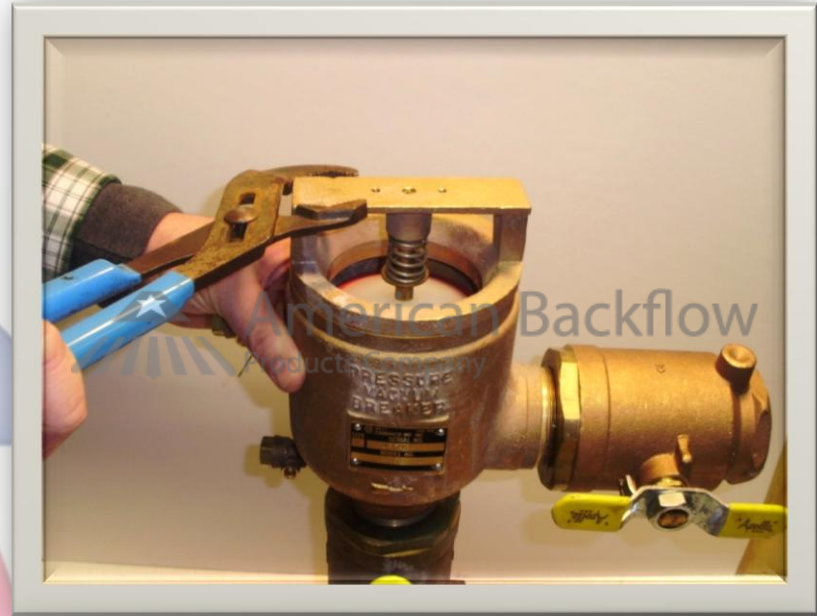
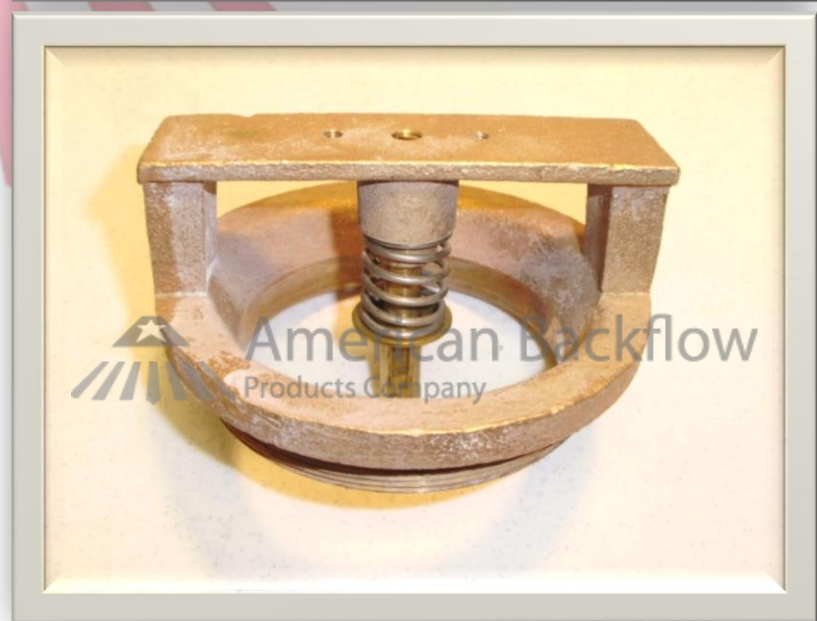
Bonnet Removal

The bonnet is threaded into the body and sealed by an o-ring.

Unscrew the bonnet counter clockwise.

There is no spring load.

If float spring is damaged, the bonnet must be replaced.

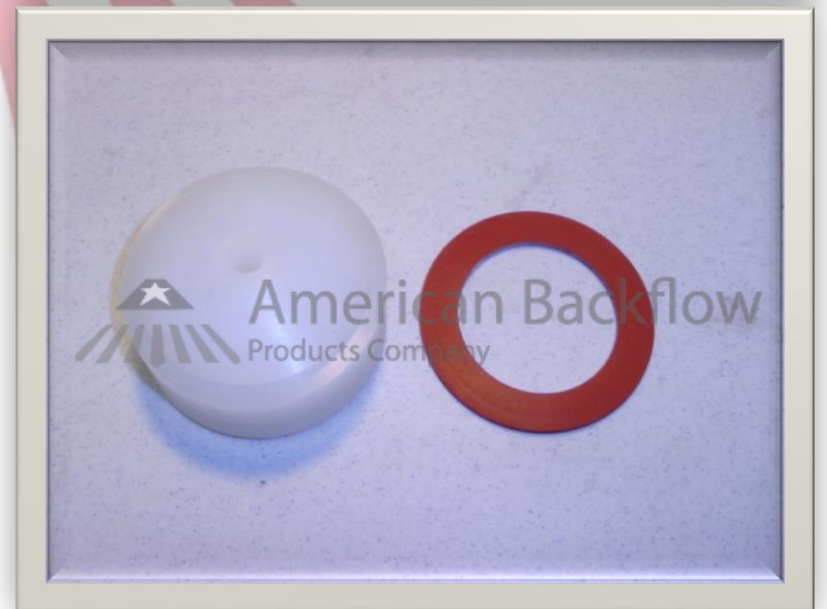
Float Removal and Service

The float is free once the bonnet has been removed.

Replace the rubber seal by pulling it from the groove on the float.

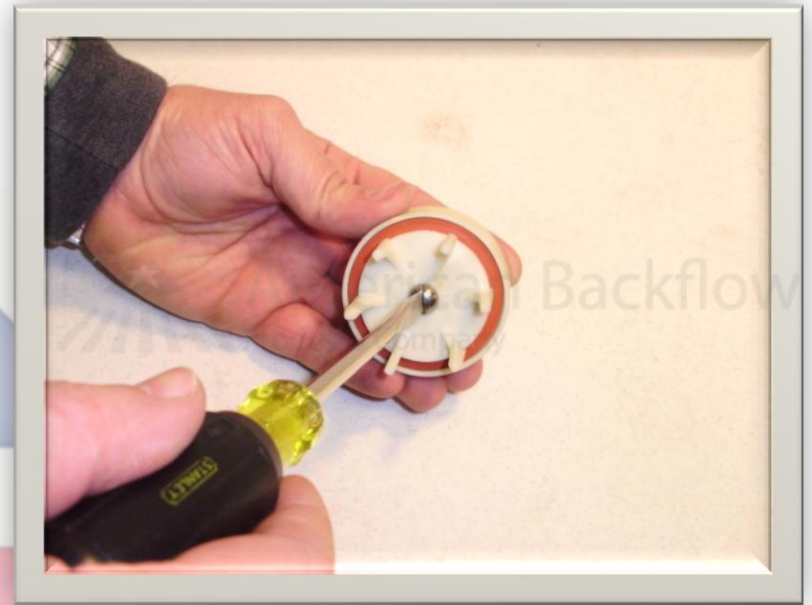
Check Disc Replacement

The check disc is free once the retaining screw and guide are removed.

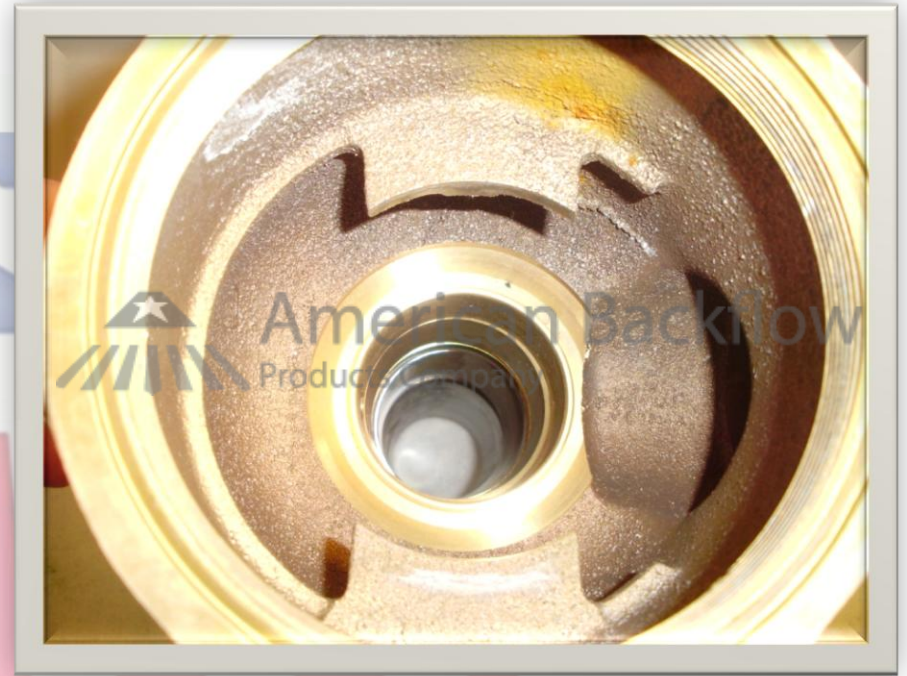
Check Seat Replacement

The check seat is part of the body.

If the seat is damaged the assembly must be replaced.

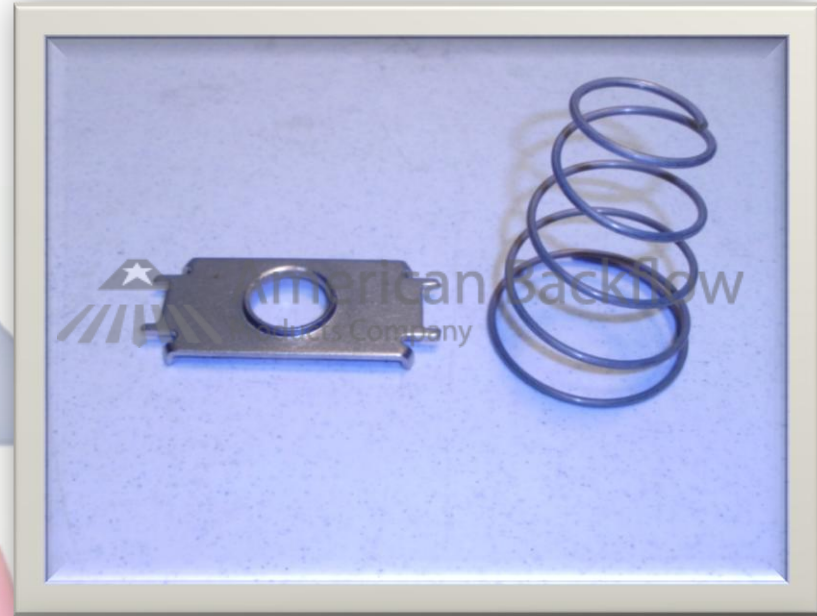
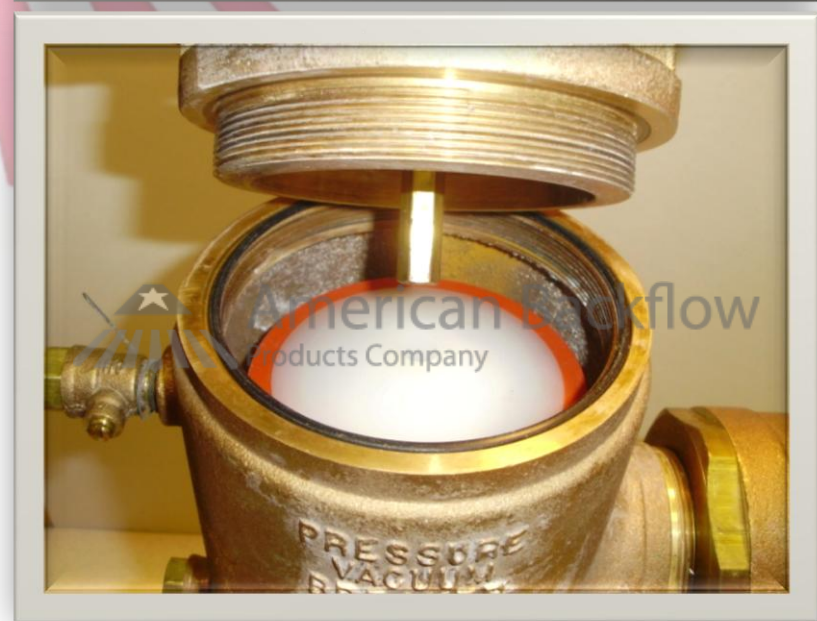
Reassembly Notes

Reassemble in reverse order.

Place large end of check spring down in body.

The lip on the retainer faces down toward the spring.

Make sure bonnet guide stem is inserted into center of float.
