# 4V-500

# 1/2" - 2"

# Modification Overview

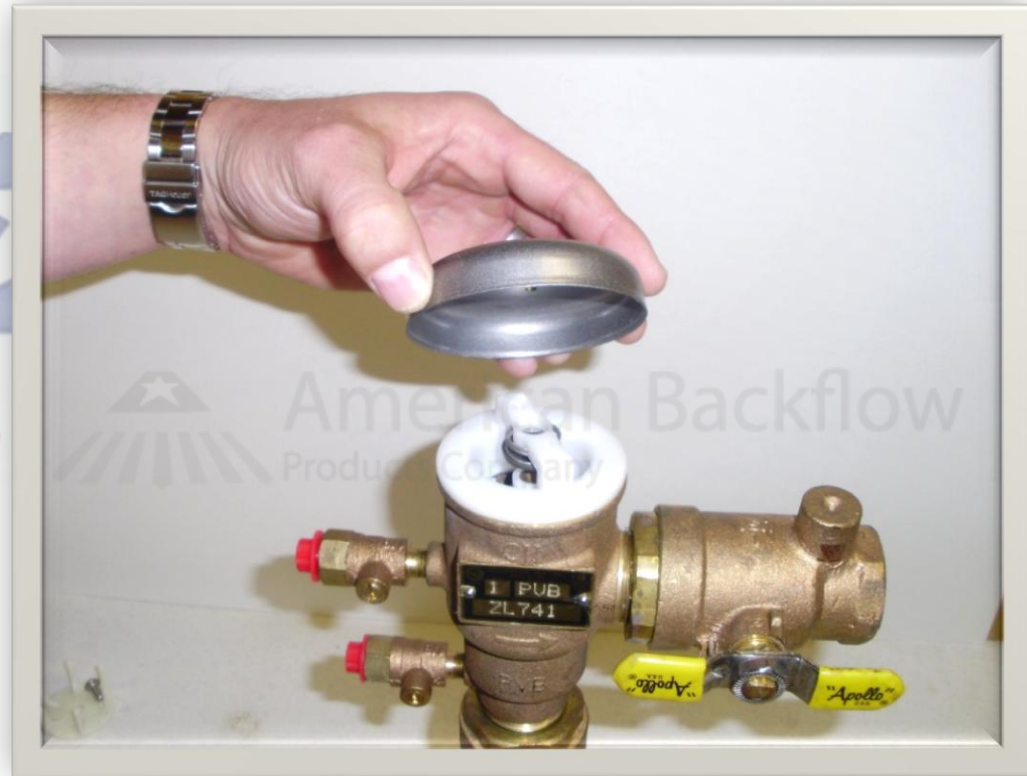
# Canopy Removal

The canopy is secured by two screws.

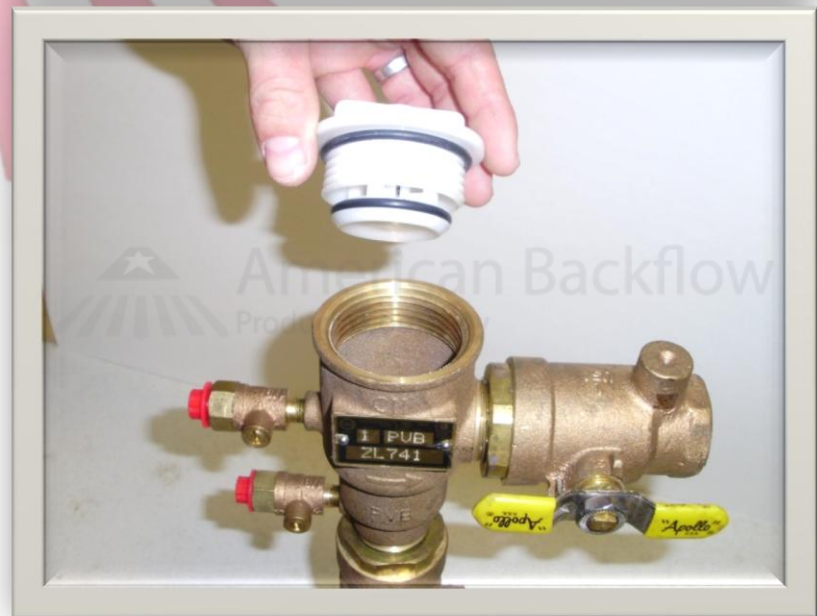
# Bonnet Removal

The bonnet is threaded into the body and sealed by an o-ring.

Unscrew the bonnet counter clockwise.

There is no spring load.

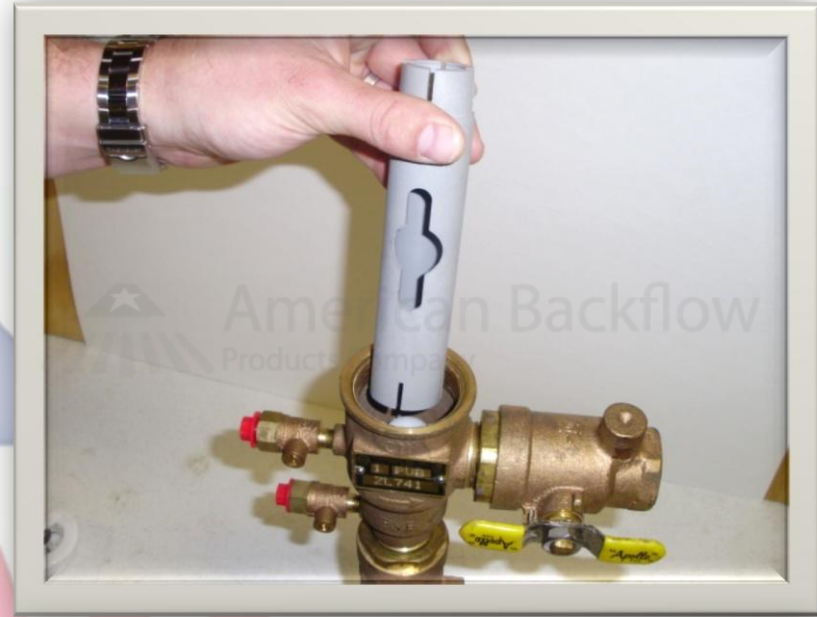
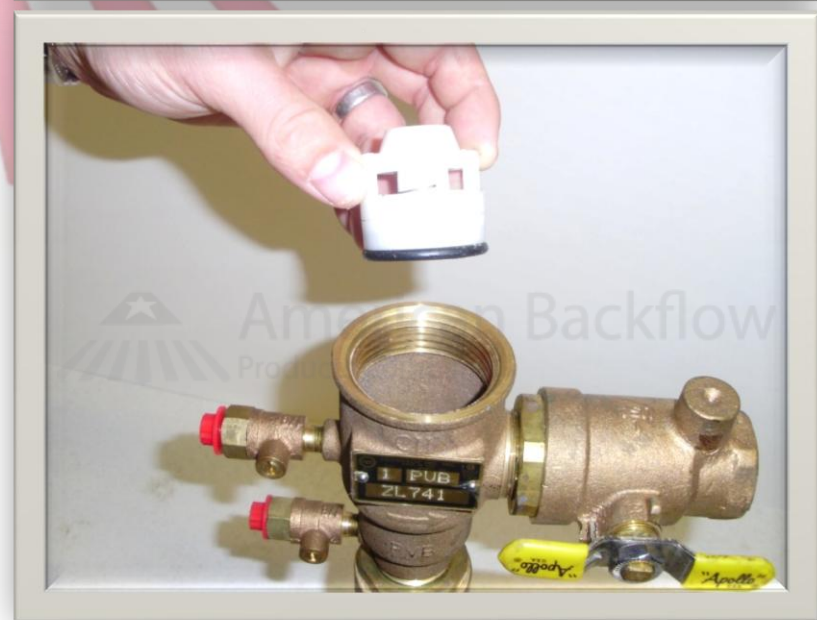
# Check Valve Removal ½”- 1”

The check valve is a module.

The check valve is threaded into the body and sealed by an o-ring.

A special tool is needed to remove the check module.
