975, 975XL ³/₄" - 2"

Modification Overview

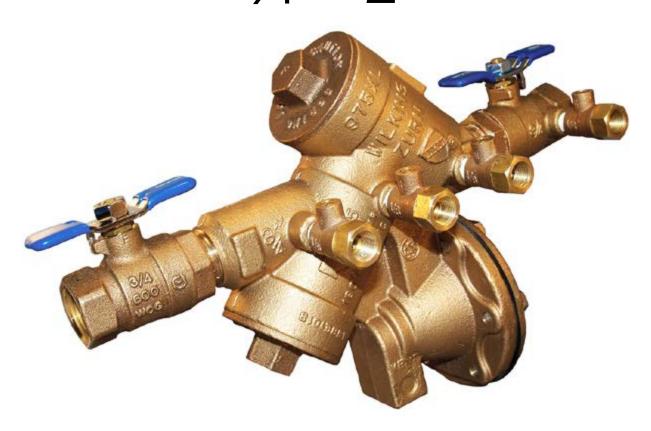
Production of the original 975 began in 1990. This version had buna-n check discs and did not have replaceable check seats. Discontinued in 1992.

The 975A had bronze replaceable seats.

The 975XL (1993-Current) has plastic replaceable seats and silicone check discs.

A lead free version 975XL2 was introduced in 2010.

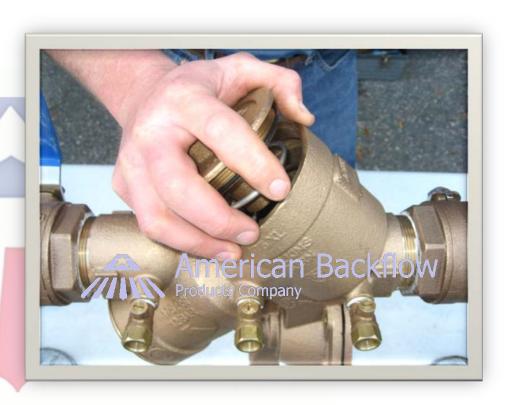
Check Cover Removal

Cover is threaded into body and o-ring sealed.

Cover is spring loaded.

Loosen cover with wrench, then remove by hand while holding tightly against spring pressure.

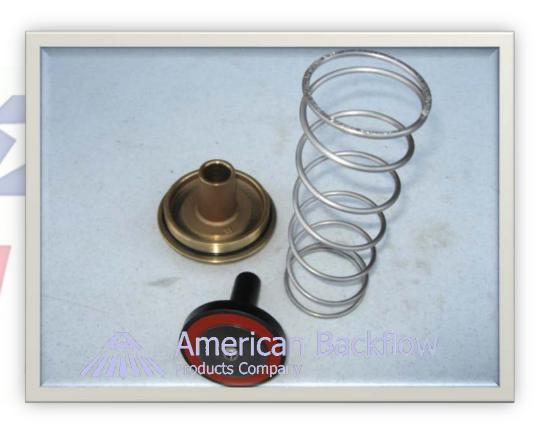
Check Valve Removal

Poppet style check valve.

The poppet and spring are free once the cover is removed.

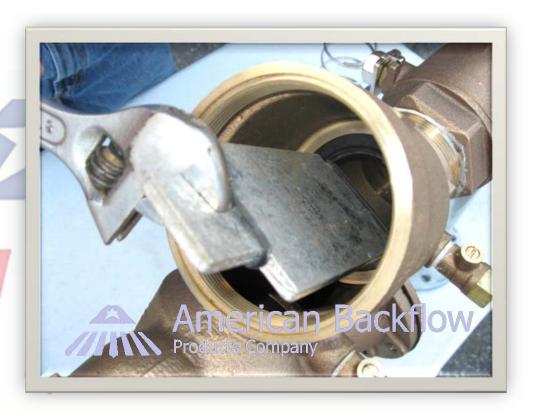
Check Seat Removal

Check seats are threaded into body and o-ring sealed.

A "special tool" is needed for removal.

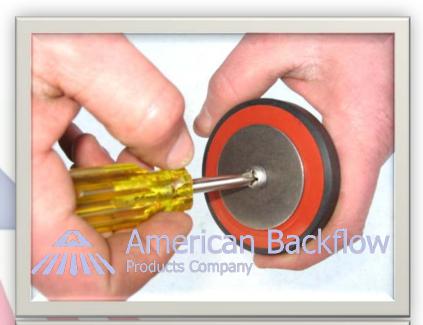
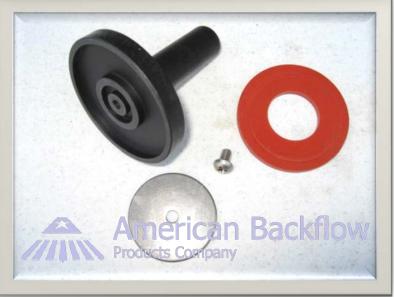
Check Disc Replacement

Remove screw and disc washer from poppet.

Reassemble in reverse order.

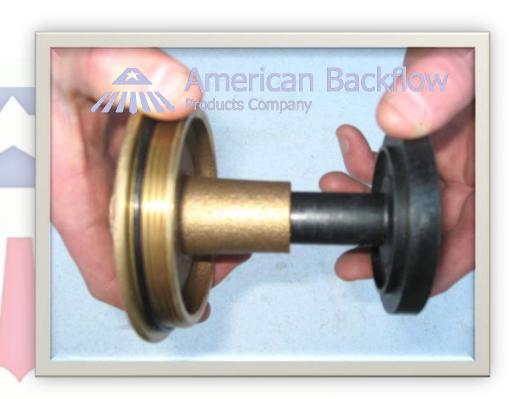
Check Valve Reassembly Notes

Inspect and clean the guide bore on the cover.

The stem must move freely in the guide bore.

Reassemble in reverse order.

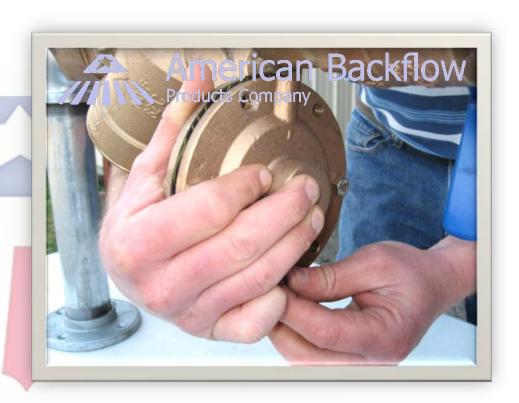
RV Cover Removal

Cover is sealed by the diaphragm.

Cover has a slight spring load.

Hold cover firmly as the bolts are removed.

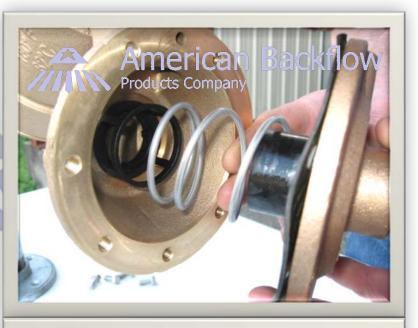
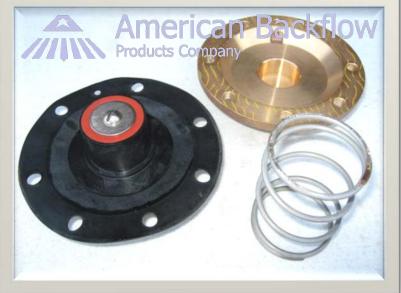
RV Stem Removal

Gently pull on the diaphragm to remove the RV stem.

The spring should fall out when the stem is removed.

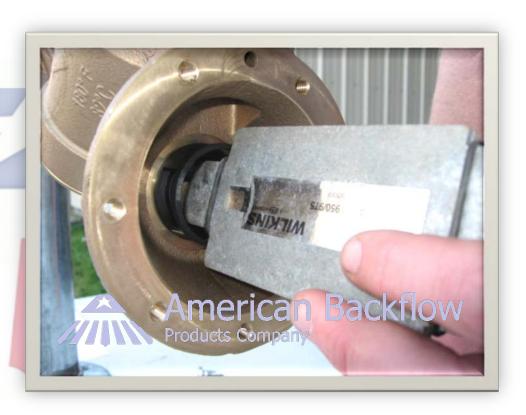
RV Seat Removal

The seat is threaded into body and o-ring sealed.

A "special tool" is needed to remove the RV seat.

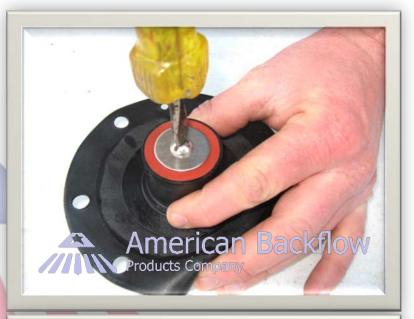
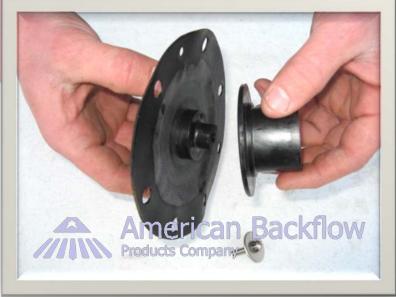
RV Stem Disassembly

Remove the retaining screw.

Pull the disc retainer and stem apart.

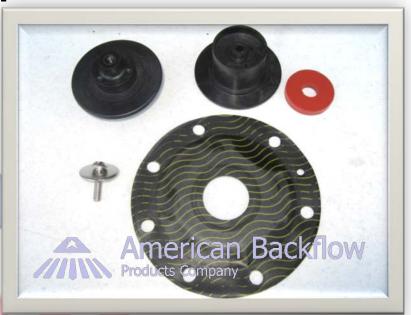
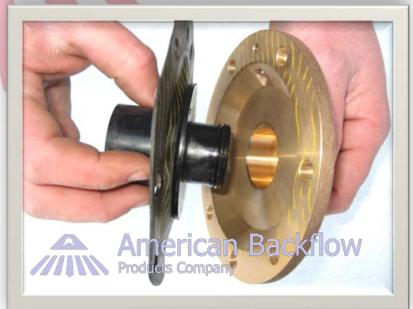
RV Rubber Replacement

The diaphragm and seat disc are free once the stem is disassembled.

Lubricate plunger oring on stem.

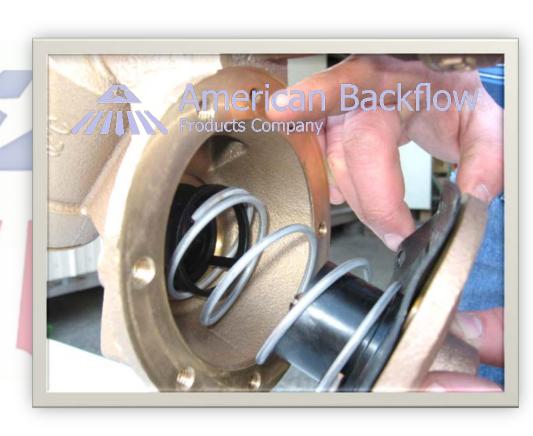
RV Reassembly Notes

Reassemble the stem in reverse order.

Position spring in body.

Make sure diaphragm does not cover hole for sensing line.
