009(M1,M2,M3), LF009 1/2"-2"

Modification Overview- 009, LF009

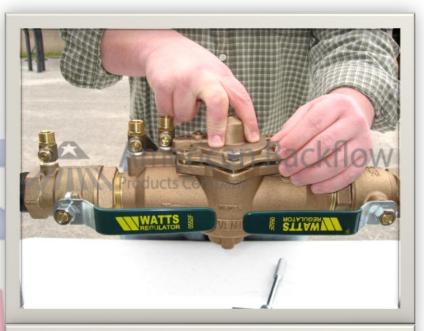
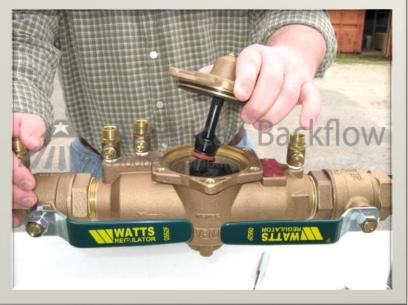
Single Access Cover Removal

Cover is o-ring sealed.

Cover has spring load from the RV spring.

- * Hold cover firmly while removing bolts.
- * RV stem may come out with cover.

Lift cover straight off.

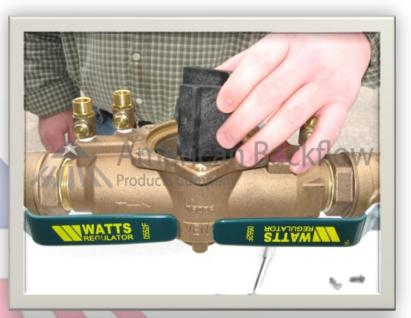
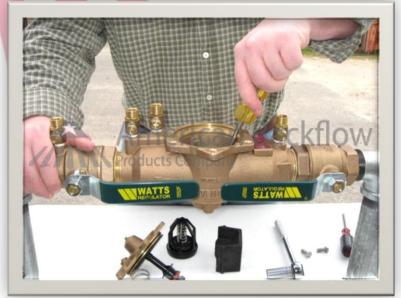
Check Valve Removal

Check valve modules.

Modules are o-ring sealed and secured by a retainer.

Slide retainer straight out of body.

Modules can now be removed by hand or with a flat head screwdriver.

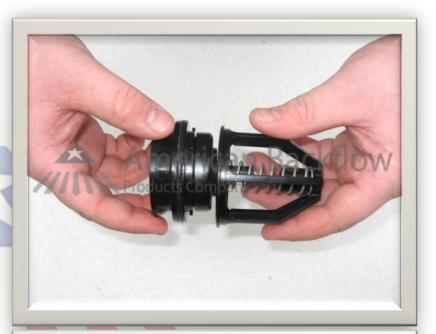
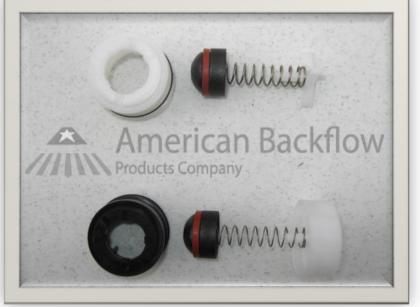
Check Seat Removal

- * Check seats are attached to the cage with a bayonet type locking system.
- * Module is spring loaded- Hold firmly.
- * Hold the cage in one hand, push the seat inward and rotate clockwise.

3/4" M2 modules snap apart.

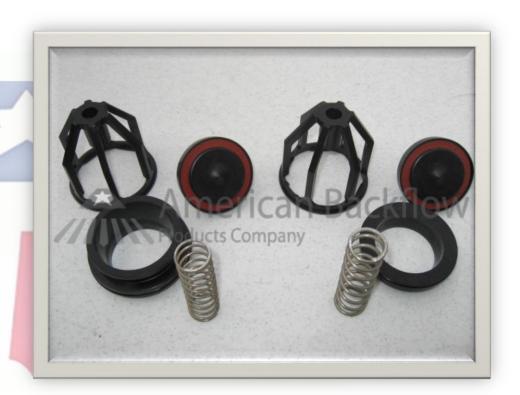
Check Disc Replacement

Check disc and disc holder can be replaced as one piece.

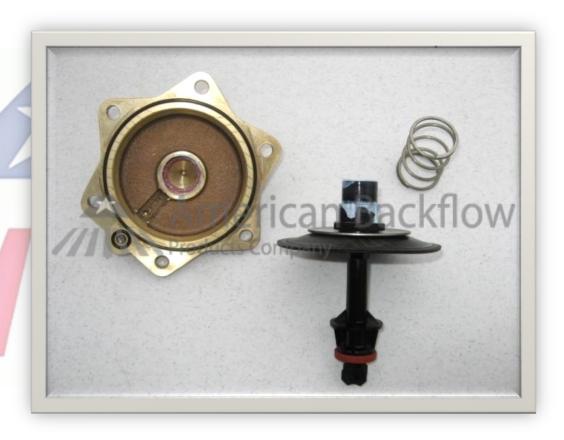
RV Stem Removal

The RV stem and spring are situated between the check valves and are free once the single access cover is removed.

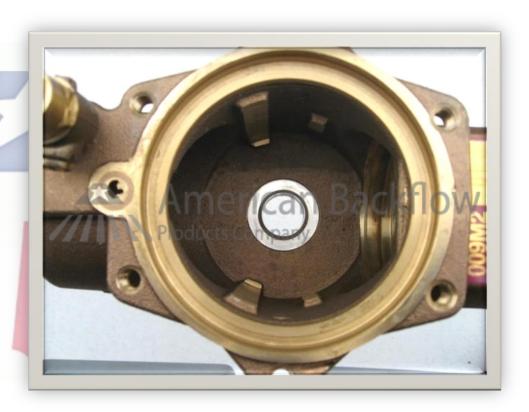
RV Seat Removal

Unless damaged, there is no need to remove RV seat.

The seat is pushed firmly into the body and is o-ring sealed.

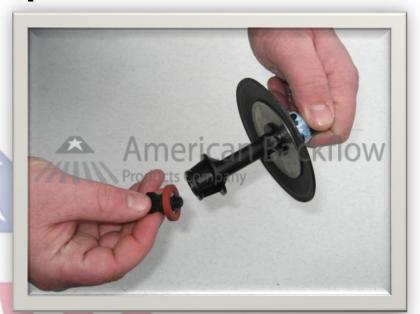
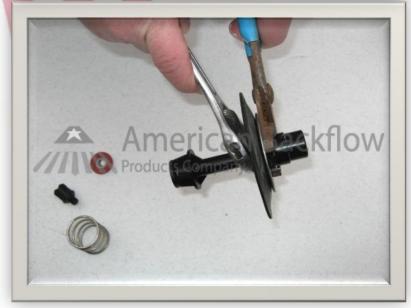
RV Rubber Replacement

The RV molded disc is on the lower stem. *Simply unscrew the guide from the stem.

The diaphragm is on the upper stem. *Simply unscrew the stem cap from the stem.

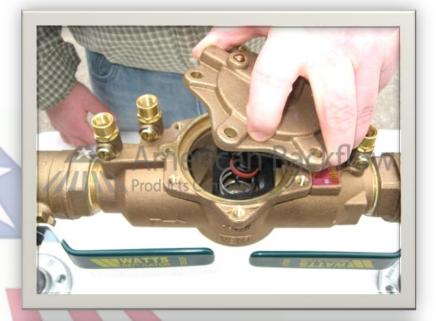
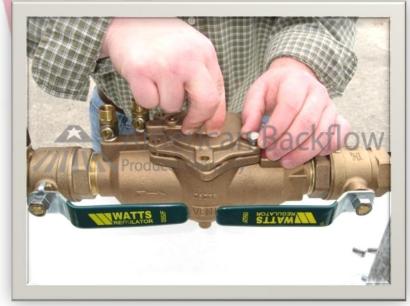
RV Reassembly Notes

Center the spring on the seat and insert the cover and RV assembly as a unit straight into the body.

Make sure that the lower guide on the RV stem goes through the guide hole in the seat.

If the cover will not press flat against the body, the stem is crooked and must be realigned.
